# Exploded view of general assembly and parts list

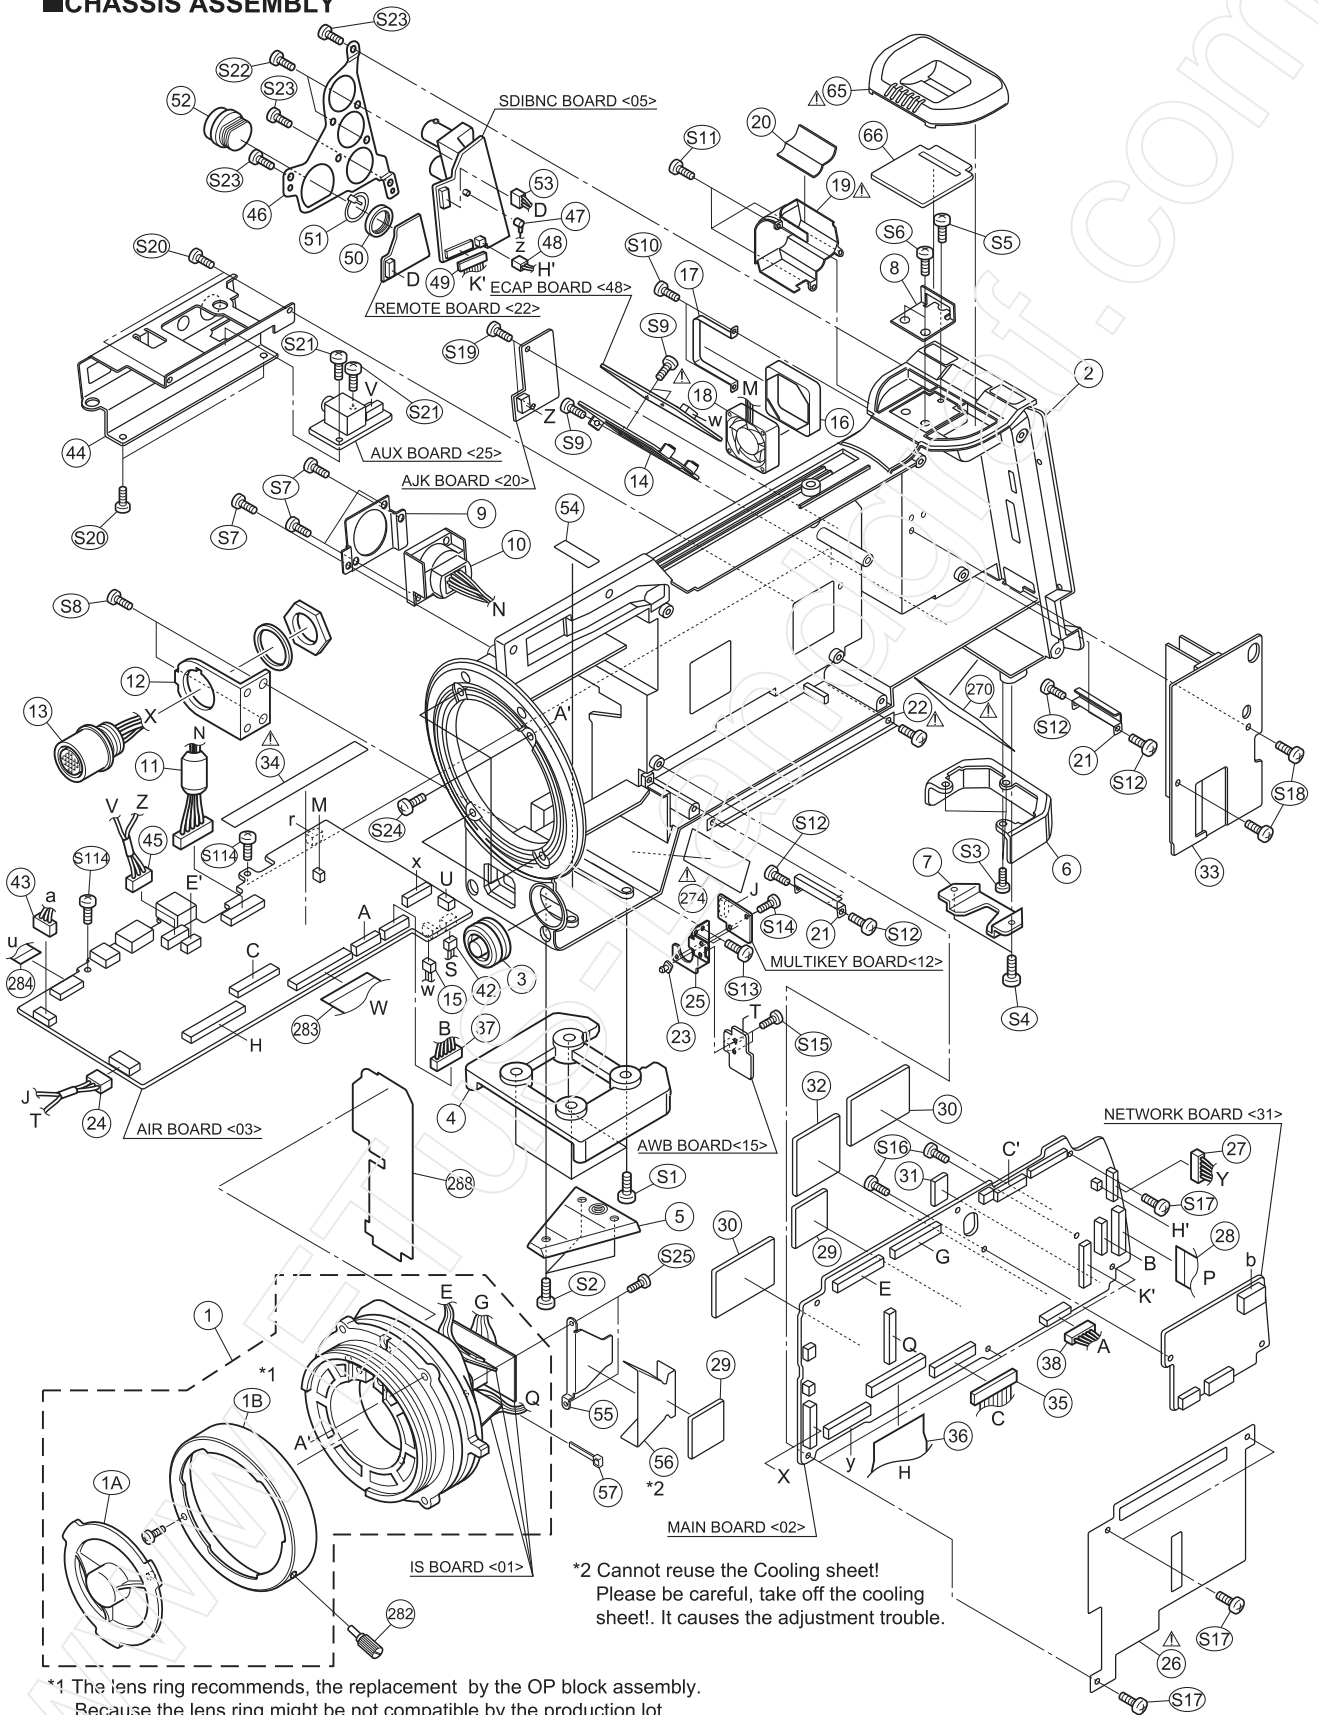
# CHASSIS ASSEMBLY

\*1 The lens ring recommends, the replacement by the OP block assembly. Because the lens ring might be not compatible by the production lot.

\*2 Cannot reuse the Cooling sheet! Please be careful, take off the cooling sheet!. It causes the adjustment trouble.
